# Folly Lane, Trans Pennine Trail Case Study

## Trans Pennine Trail – Folly Lane

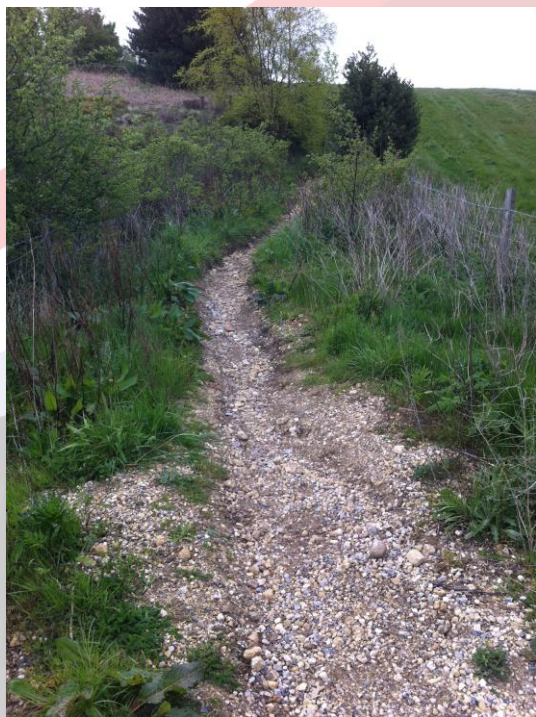
Above: The naturally formed path was also a nuisance for pedestrian users and cyclists, having gone past the point of being rugged terrain and in to the realms of being unsafe.

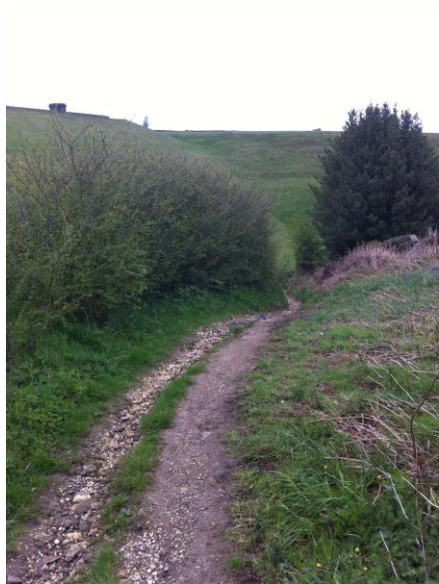
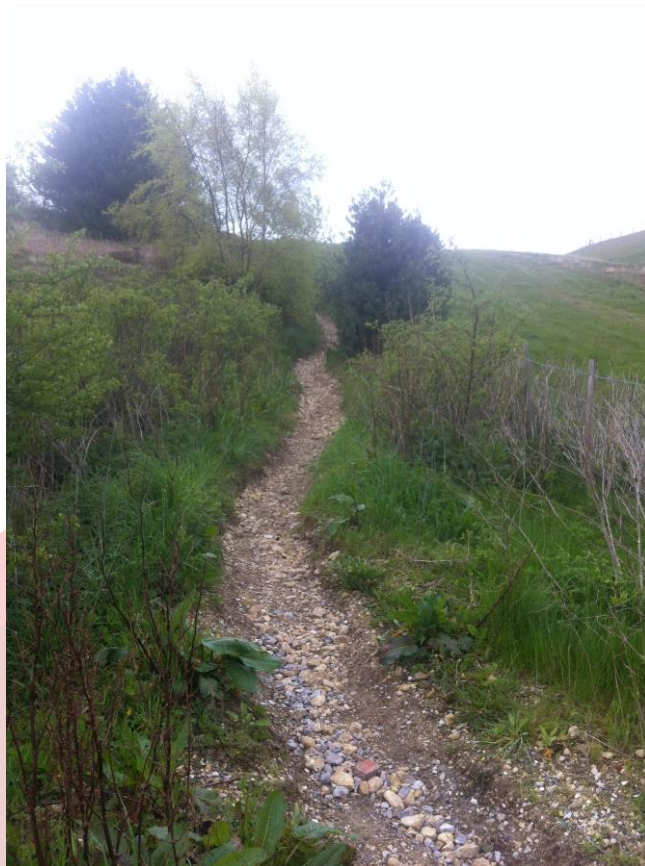
Above & Right: Both the Trans Pennine Trail and Yorkshire Water wanted the full potential of the bridleway to be realised. The use of KBI Flexi™-Pave meant that only minimal ground works were required.

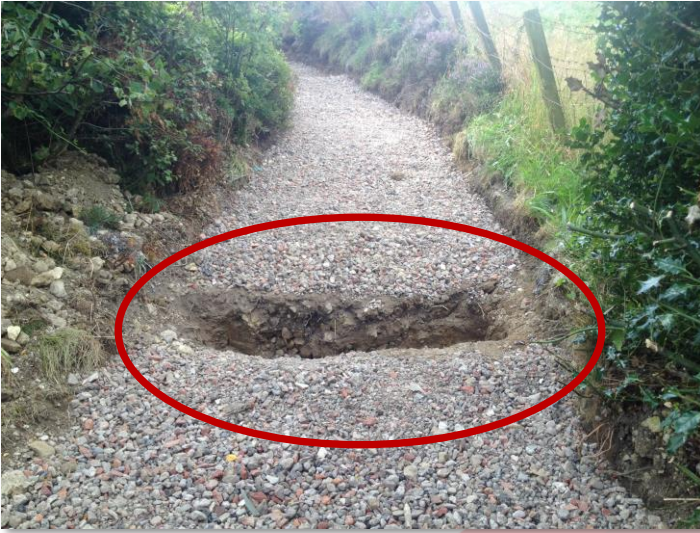
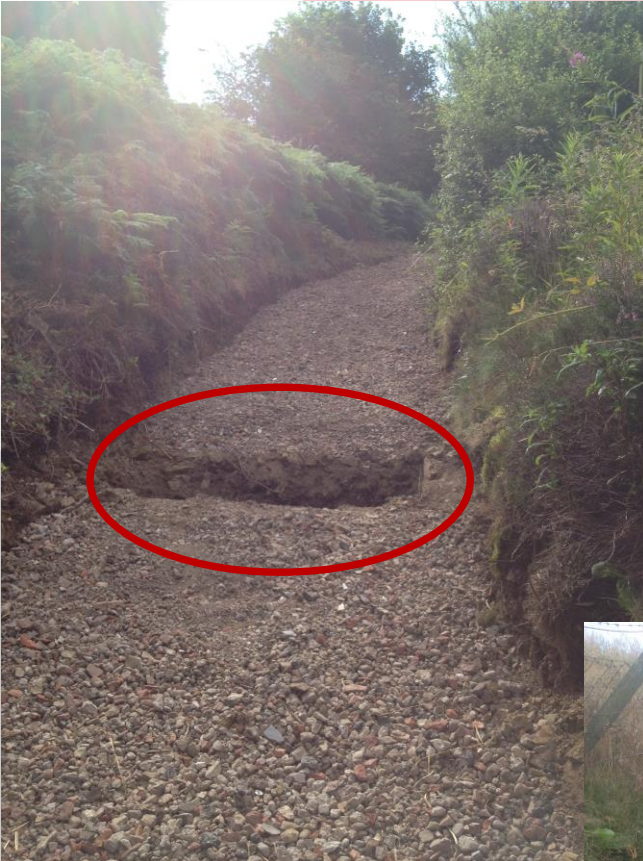
This page: Having widened the existing path, baffles were dug in to the steeper inclines to allow water to effectively recharge back into the ground after penetrating through the KBI Flexi™-Pave. The baffles (circled) also reduce the migration of the stone used within the sub-base, helping to ensure a stable path.

Once dug, each baffle was filled with KBI Flexi™-Pave, eliminating the possibility of the channel becoming clogged whilst still allowing the free movement of water.

The use of baffles – which were dug at various intervals along the slopes – helps to attenuate the flow of water down the slope once it passes through the KBI Flexi™-Pave. The baffles also establish a stronger path as they stem the migration of the stone sub-base - a simple yet effective solution to ensuring that the pathway behaves exactly as it should.

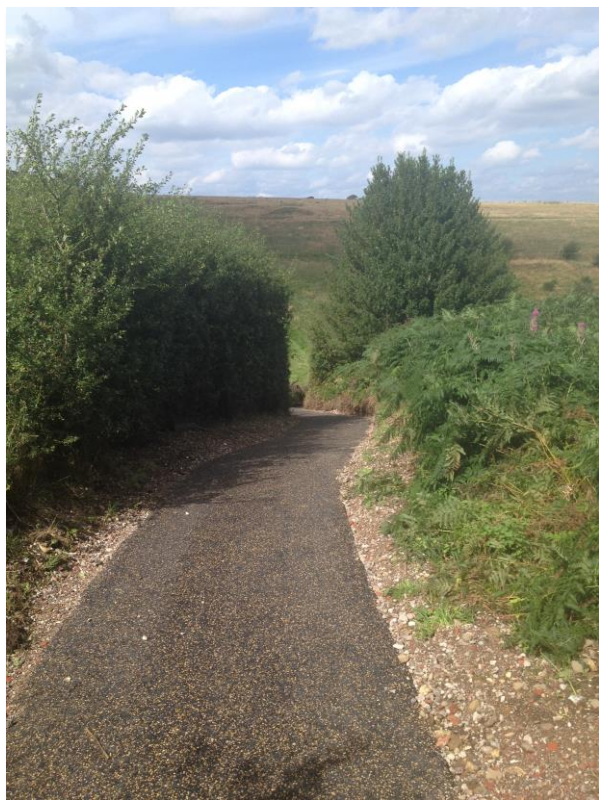
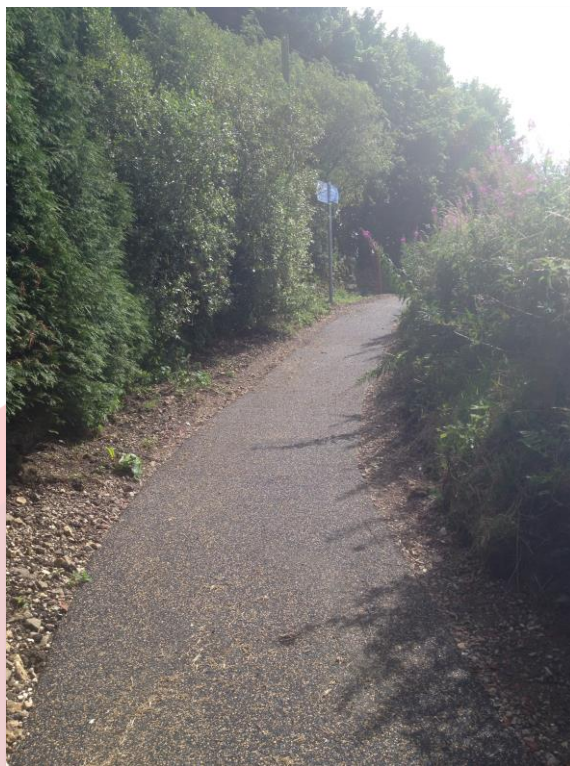
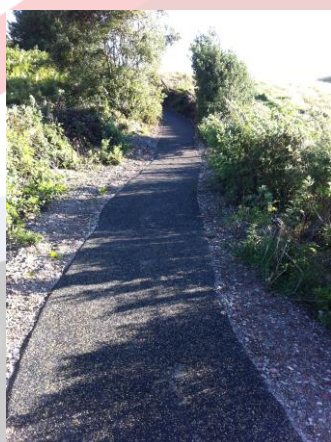
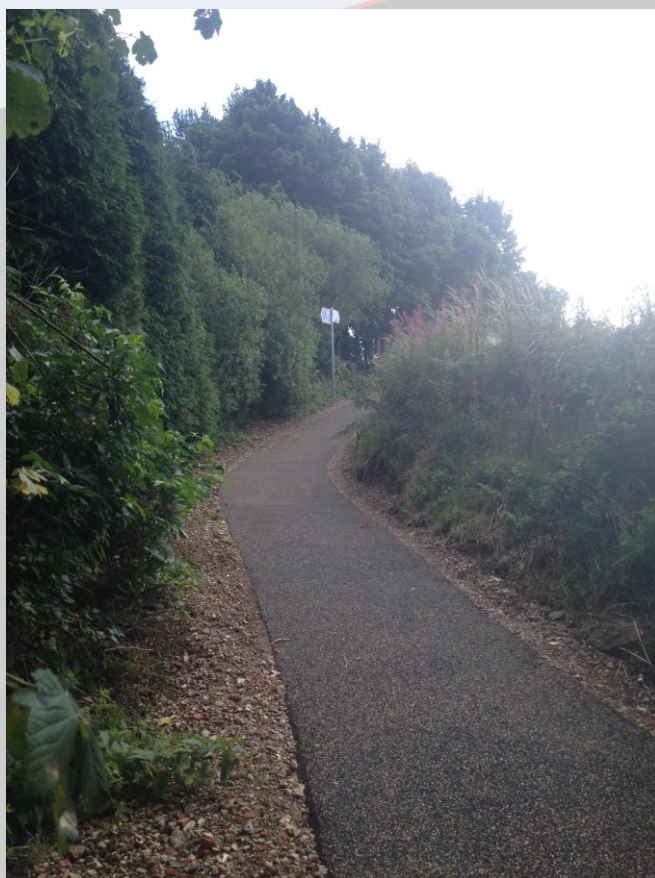
This page: The finished bridleway conforms to the natural contours of the original path and is completely porous. The recycled rubber used within the material not only makes it eco-friendly, it reduces the impact on the leg joints of the horses using the bridleway.

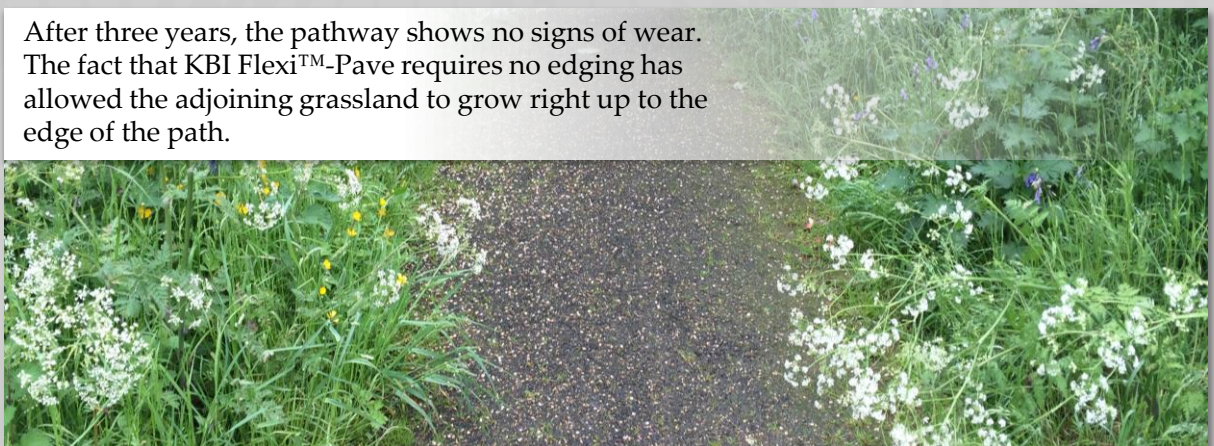
After three years, the pathway shows no signs of wear. The fact that KBI Flexi™-Pave requires no edging has allowed the adjoining grassland to grow right up to the edge of the path.

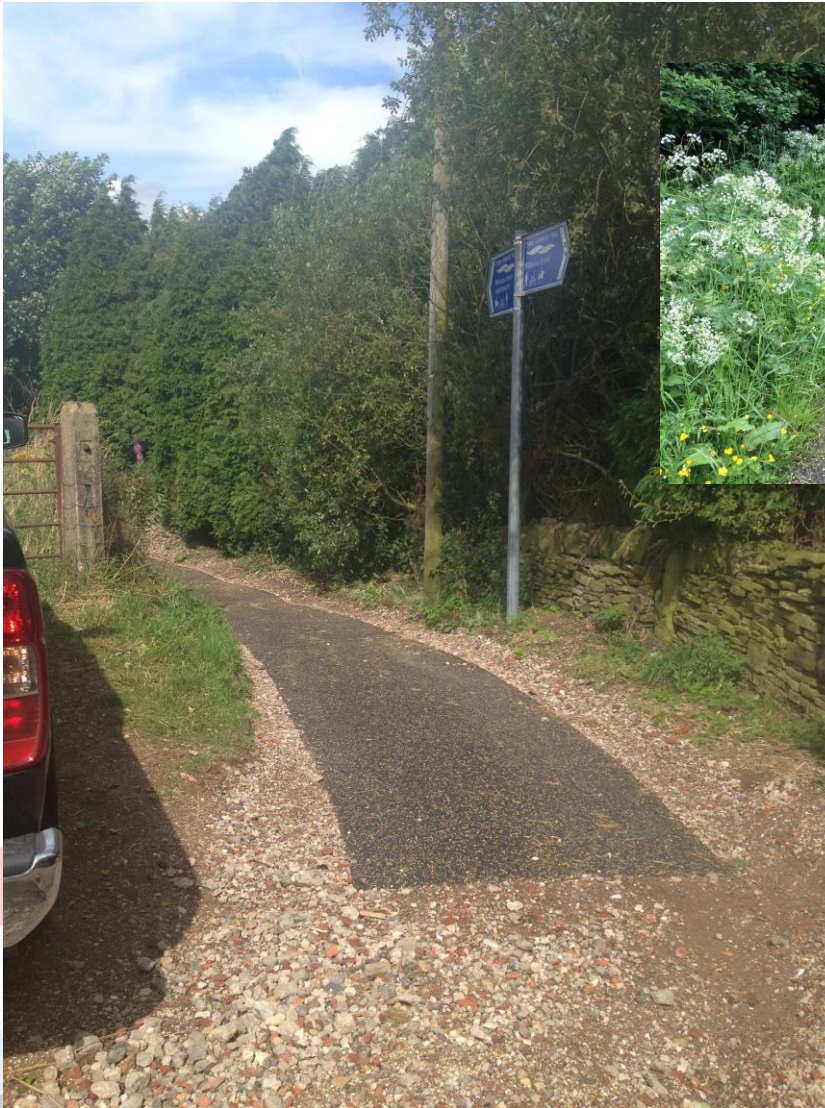
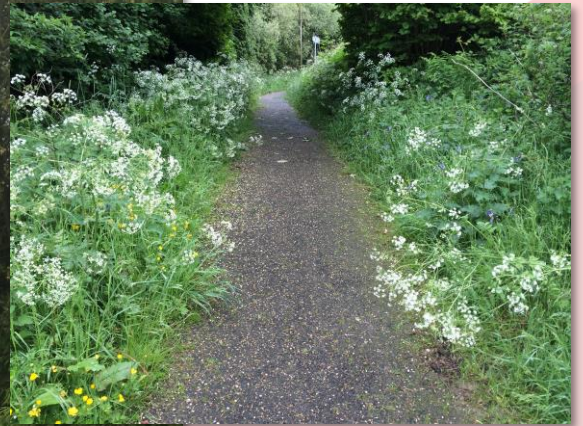
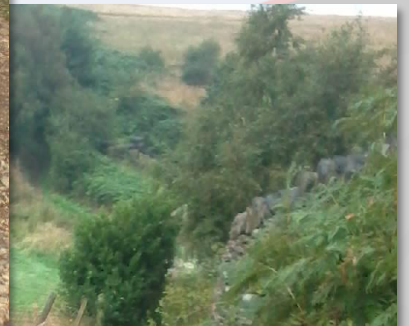
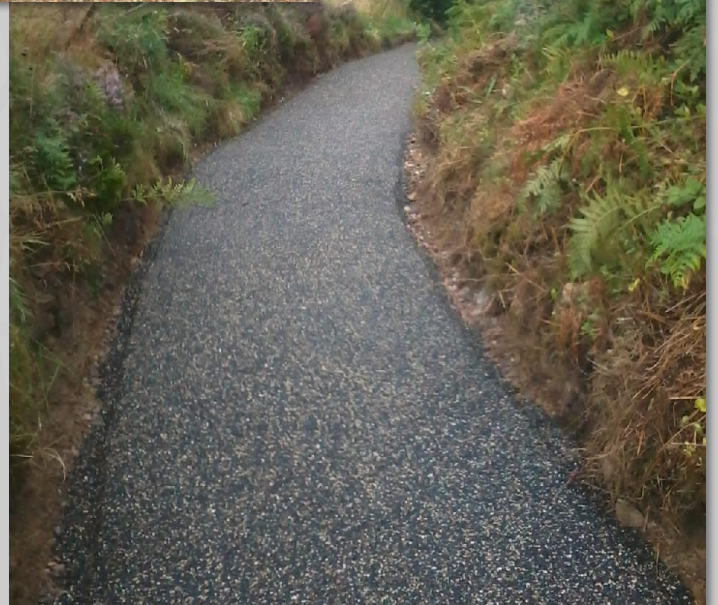
This page: Despite challenging conditions and difficult terrain, the Folly Lane stretch of the Trans Pennine Trail is now fully accessible to equestrian users as well as pedestrians and cyclists. With erosion no longer a problem, the path also benefits from zero standing water.
